Water Structures Category

Repair of Wisla-Czarne Dam Concrete Structures

Wisla, Poland

Submitted by **Osrodek Techniki i Kooperacji OTiK Sp. z o.o.**

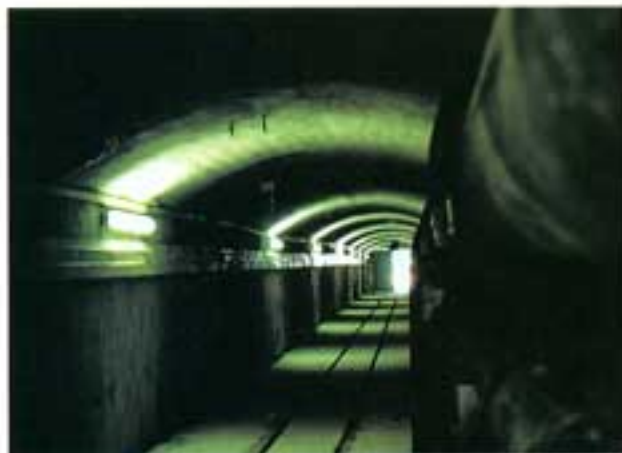
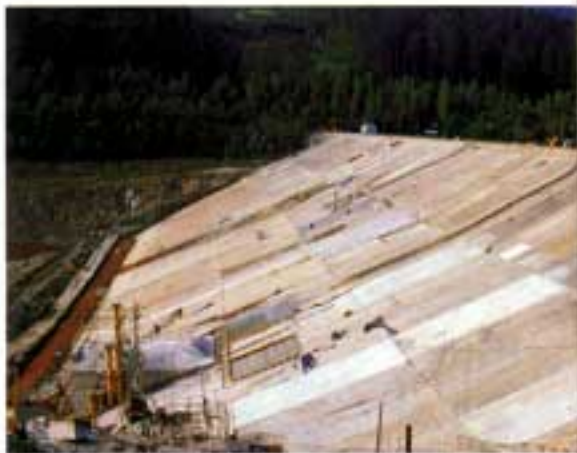
The Wisla-Czarne Dam is a small earth dam built in 1973. Workmanship faults, poor concrete quality, and exposure to severe environmental conditions caused deterioration of the concrete, which was unsuccessfully repaired several times over the years. This project allowed the evaluation of the structures to detect the damage that was causing the water infiltration. Test repairs were performed that enabled the selection of effective repair materials and sealing methods for underground tunnels being repaired 25 meters below water level. Six years of field testing were conducted to check durability and to select the best material for protection of the concrete shield against wavy motion and ice float aggression. Field corrosion monitoring was performed to determine the proper repair system for the carbonated walls of the overflow channel.

Once the research was completed, the project was awarded. Once the repairs began, different structural faults of the expansion joints were detected and repaired. Each of the renovated structures (service and monitoring tunnels, bottom outlet valves chamber, concrete shield on the upstream side of the dam, overflow channel, bridge over the overflow channel, and discharge basin)

demanded different, individually selected repairs and protection dedicated to local exposure conditions. All repairs were successfully completed and water infiltration was dramatically reduced.
